**PROPOSAL FOR ADMINISTRATIVE
NO FURTHER ACTION
ENVIRONMENTAL RESTORATION
SITE 135, BUILDING 906 SEPTIC SYSTEM
OPERABLE UNIT 1303**

August 1994

**SITE 135, Bldg. 906 Septic System
OU 1303**

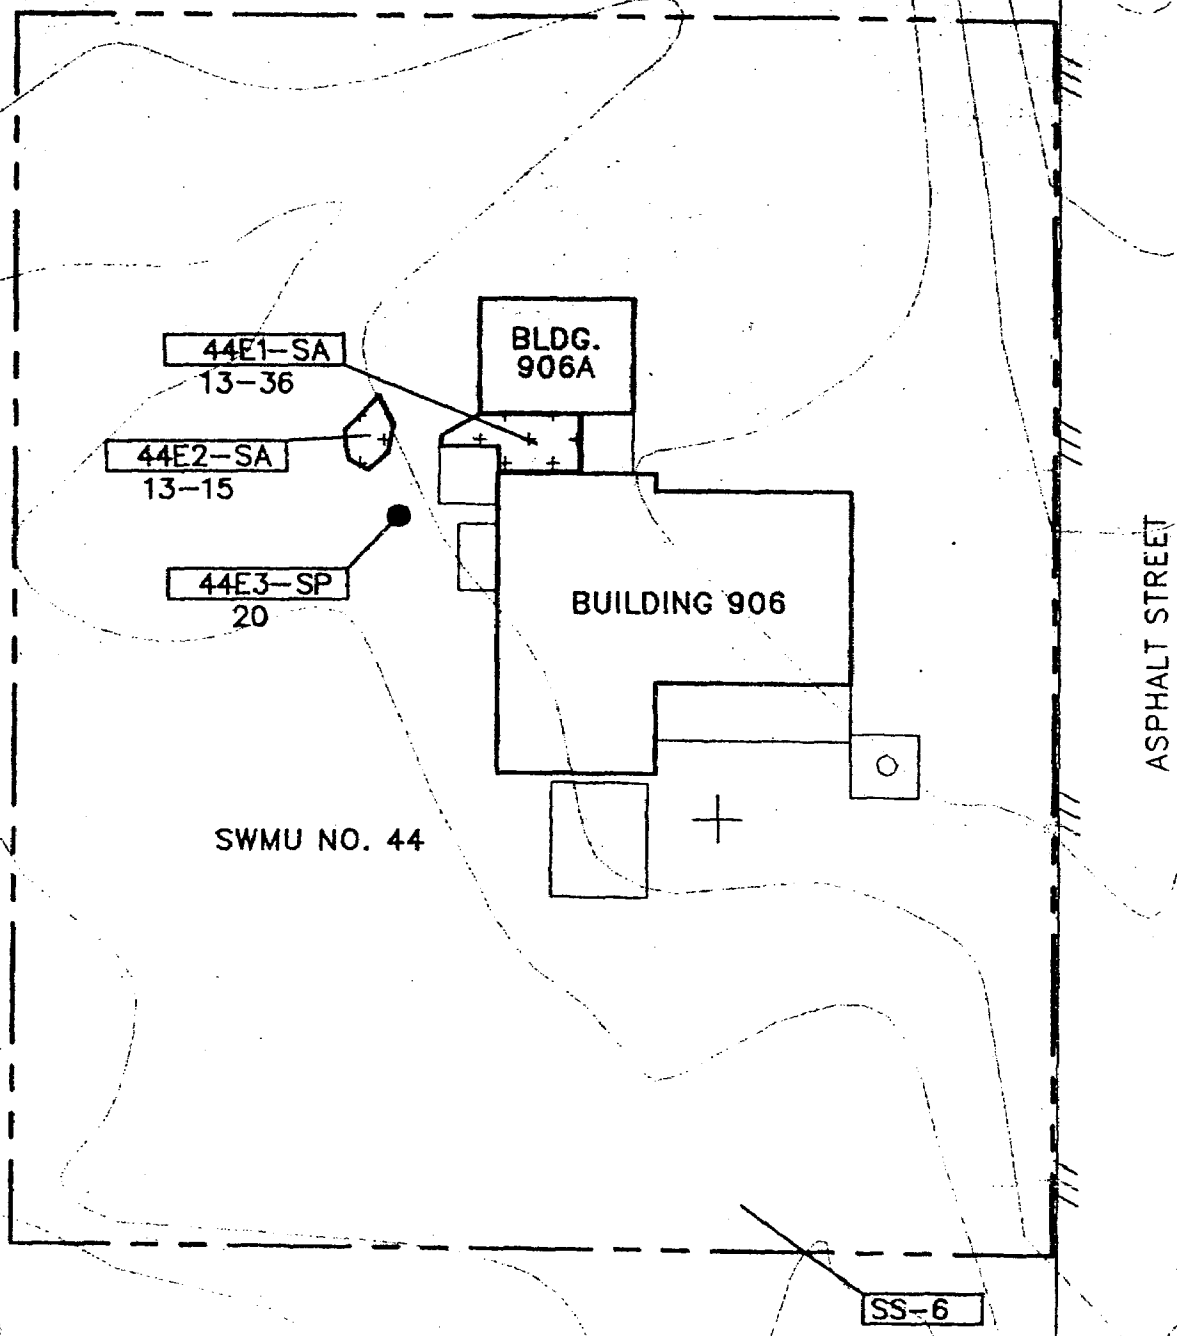
Attachment 2

On March 20, 1994, a surface radiation survey was performed over the Building 906 septic system leachfield area. The surface area surrounding Building 906 has been identified as ER Site #44, Decontamination Area. The radiation survey was performed using a gamma scintillometer, at six-foot centers (100% coverage) over the entire site area, and a pressurized ionization chamber (PIC). In the area west of Building 906, background activities were measured between 11 to 13 mR/h with the PIC. Three areas, all within 15 feet of the building, were identified with gamma activity that was 30 percent or greater than the natural background. These anomalies are soil in nature with no visible evidence of radioactive material (i.e., DU fragments, uranium oxide). The anomalous areas have been identified as 44E1-SA, 44E2-SA, and 44E3-SP (Attachment 2). Exposure rates were measured between 13 mr/hr to 36 mr/hr at location 44E1-SA, 13 mr/hr to 15 mr/hr at location 44E2-SA, and at 20 mr/hr at location 44E3-SP. This information will be incorporated into the ER Site #44 SWMU investigation.
